## FIRE AND WATER DAMAGE RESTORATION FOR INDUSTRY, BUSINESS AND HOUSEHOLD WATER DAMAGE TO GYM, ARTH SZ

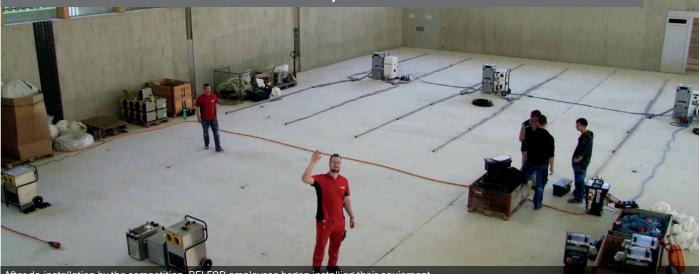
After de-installation by the competition, BELFOR employees began installing their equipment.

The entire sub-floor from the changing areas, gym to the equipment room was flooded due to a break in the main water line of the heating system. We determined together that the drying work should take place during the summer school holidays. We immediately called attention to the fact that the surface could become saturated if we waited ten weeks to start the drying process!

- The initial situation required insulation layer drying
- The competition already got the job
- However the Basler insurance company was not satisfied with the work
- BELFOR was allowed to bid and got the job
- Set-up with six drying experts
- The drying process went off without a hitch
- A drying time of four weeks was the plan
- Ongoing control measurements via CM measurements were performed
- After 21 days the measured values were already reached
- The optimal value for the gym covering is 1.5% CM
- We achieved a final value of 0.9% CM for the surfaces
