FIRE AND WATER DAMAGE RESTORATION FOR INDUSTRY, BUSINESS AND HOUSEHOLD **WATER DAMAGE TO GYM, ARTH SZ**

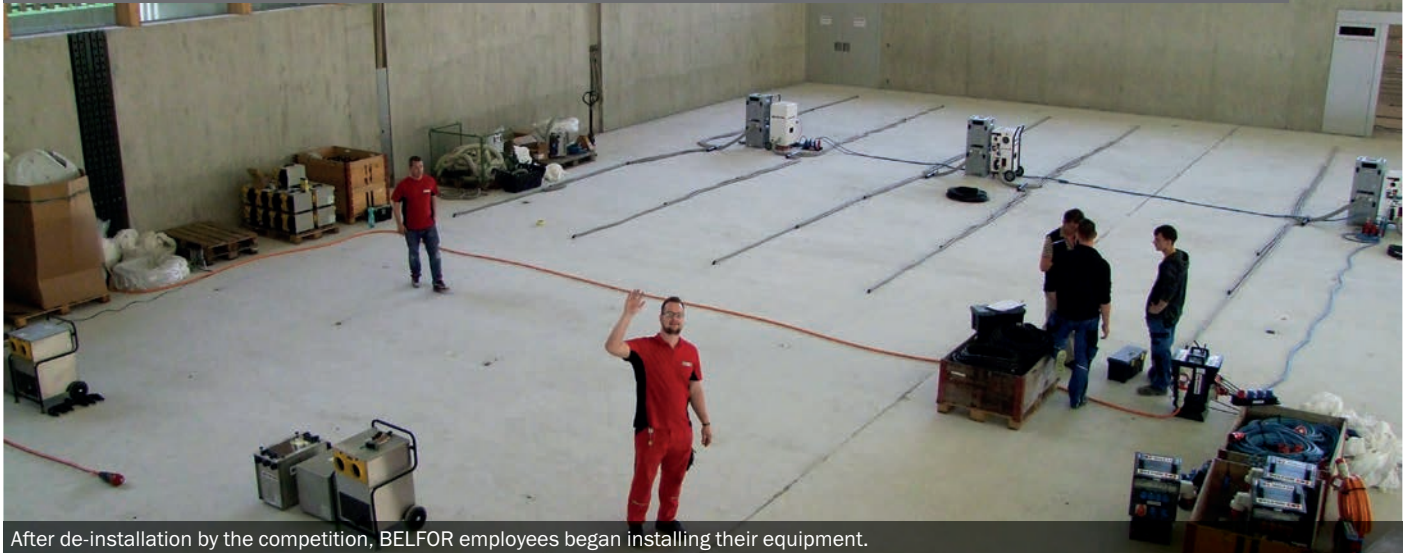
After de-installation by the competition, BELFOR employees began installing their equipment.

- The initial situation required insulation layer drying
- The competition already got the job
- However the Basler insurance company was not satisfied with the work
- BELFOR was allowed to bid and got the job
- Set-up with six drying experts
- The drying process went off without a hitch
- A drying time of four weeks was the plan
- Ongoing control measurements via CM measurements were performed
- After 21 days the measured values were already reached
- The optimal value for the gym covering is 1.5% CM
- We achieved a final value of 0.9% CM for the surfaces

The entire sub-floor from the changing areas, gym to the equipment room was flooded due to a break in the main water line of the heating system. We determined together that the drying work should take place during the summer school holidays. We immediately called attention to the fact that the surface could become saturated if we waited ten weeks to start the drying process!

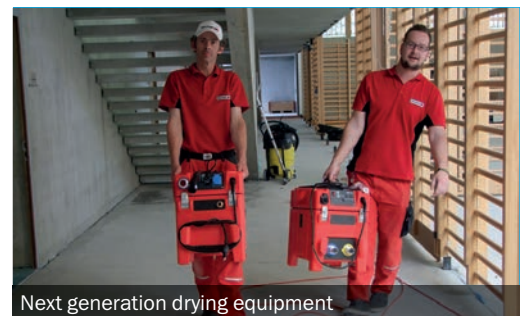
Next generation drying equipment
