PROPERTY RESTORATION

First Congregational United Church of Christ Vancouver, Washington

Loss Event: Arson Fire

CASE STUDY

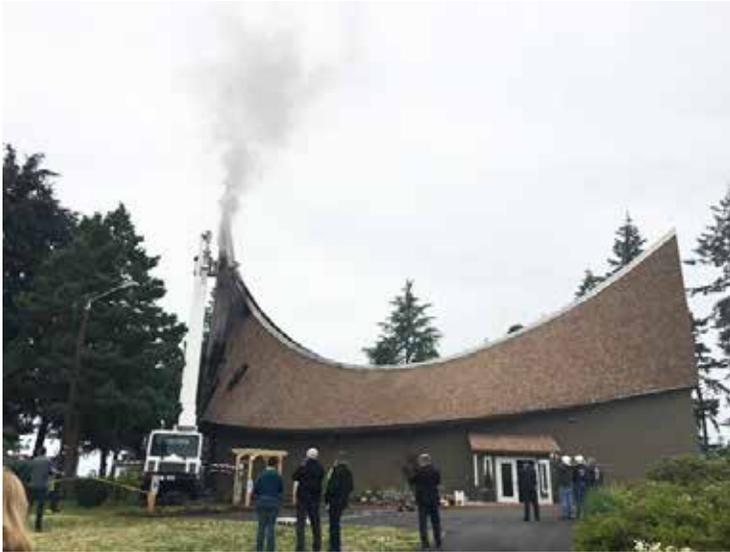
Demolition crews disassembled the roof structure. They preserved the original hardware and structural plates to be refinished and reused in preparation for the new, custom glulam beams.

BELFOR contacted the original company that fabricated the original beams in 1962. Not only was each roof glulam beam custom made, but every beam also had to be precisely cut at angles with tolerances of $\frac{1}{2}$ of 1 degree. Given that the radius of the rooflines are curved and arched, both the interior and exterior sides of each beam had to be beveled. This allowed the roof sheathing and furring strips to be bent and installed in a seamless, flowing manner.

With the new beams ready to go, BELFOR began the process of removing the damaged roofing and framing materials. The large beam assemblies had to be transported on semi-trailers and pre-assembled in the nearby parking lot. Using large forklifts, a hydraulic crane, and every inch of the 125-foot articulating lift, crews set each custom-built glulam beam and collar ties precisely as planned. Together with the congregation, BELFOR reinstalled the iconic cross back atop the peak of the roof. The congregation gathered ceremoniously to celebrate this symbolic event.
