YMCA of Grants Pass Grants Pass, Oregon

Loss Event: Mold Damage

BELFOR RESPONSE

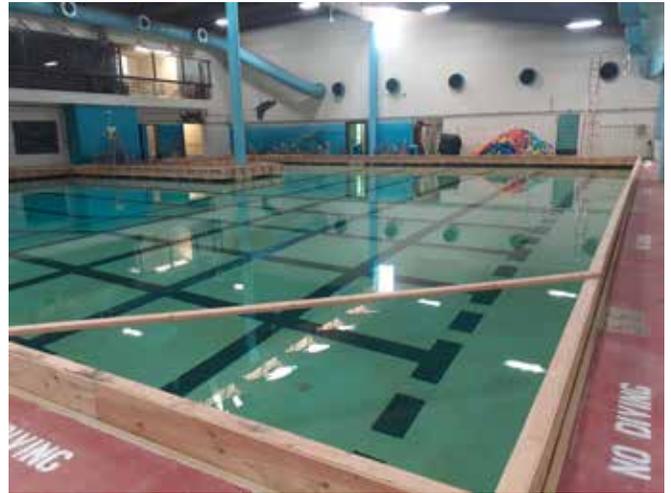
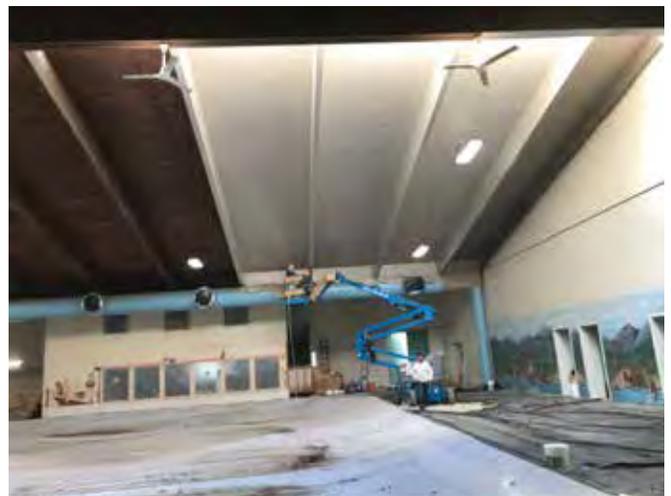
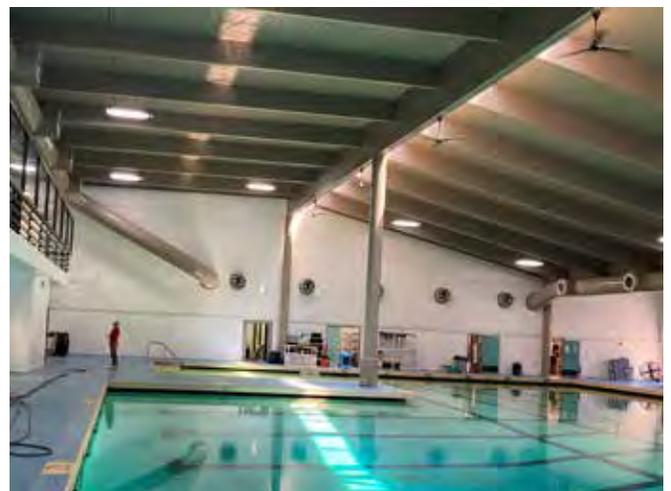
The pool room is 13,000 square feet ft. with ceilings as high as 28 feet. The pool stretches approximately 80 feet by 72 feet at depths from 3-13 feet. The ceiling structure was comprised of exposed wood beams, plus tongue and groove decking, and a large skylight running the length of the room.

Mold contamination was widespread, requiring heavy cleaning and sanding, mold sealing, and finish painting of all surfaces. BELFOR brought in approximately 15-20 crew members to handle the project, including a mold hygienist. BELFOR performed remediation and painting in the peripheral rooms (four locker rooms with restrooms, party room with kitchenette, daycare room and changing rooms).

The bulk of the remediation occurred over the top of the pool which could not be drained. BELFOR had to frame a platform around the pool so it could be tarped off entirely, protecting the pool and water from debris and contaminants. BELFOR used aerial lifts to reach otherwise inaccessible places, pull the skylight and drop in from the 4-roof system.
