TULANE UNIVERSITY RECOVERY— BELFOR'S FULL-SERVICE SOLUTION

Tulane University

Hurricane Katrina Restoration

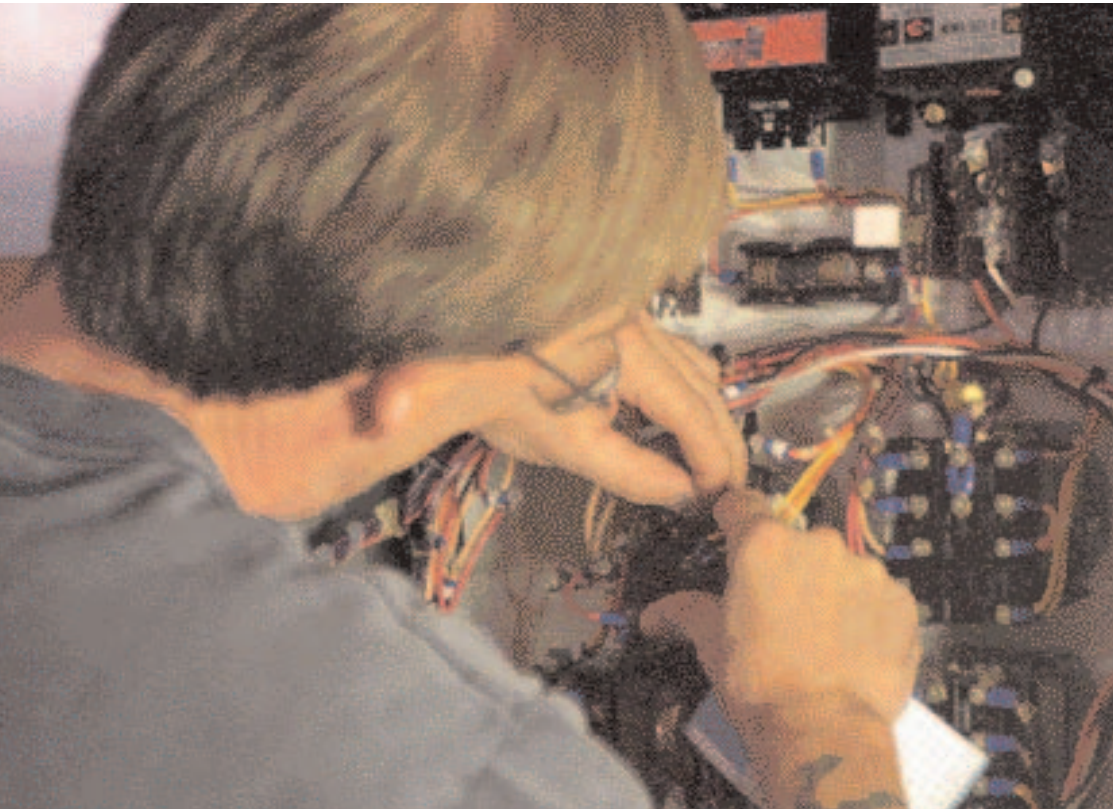
1. BELFOR cleaned out all of the switchgear and transformers in each individual electric vault, which saved Tulane restoration time and thousands of dollars in equipment.
2. To eliminate potential risks, protective gear including hard hats and respirators were required of all BELFOR employees at all times.
3. BELFOR worked to decontaminate and remove corrosive material from the bare metal surfaces on a large electric motor.
4. High-voltage terminals on all large electrical switches were decontaminated.
5. BELFOR assessed and disassembled contaminated electrical and mechanical components to allow for thorough ultrasonic cleaning.

the back portion of campus, cleaning out the individual electrical vaults in each building to get them back on line. Without this important step, it would have been necessary to purchase new equipment, which would have delayed the project for weeks. BELFOR saved Tulane months of time and a significant amount of money.

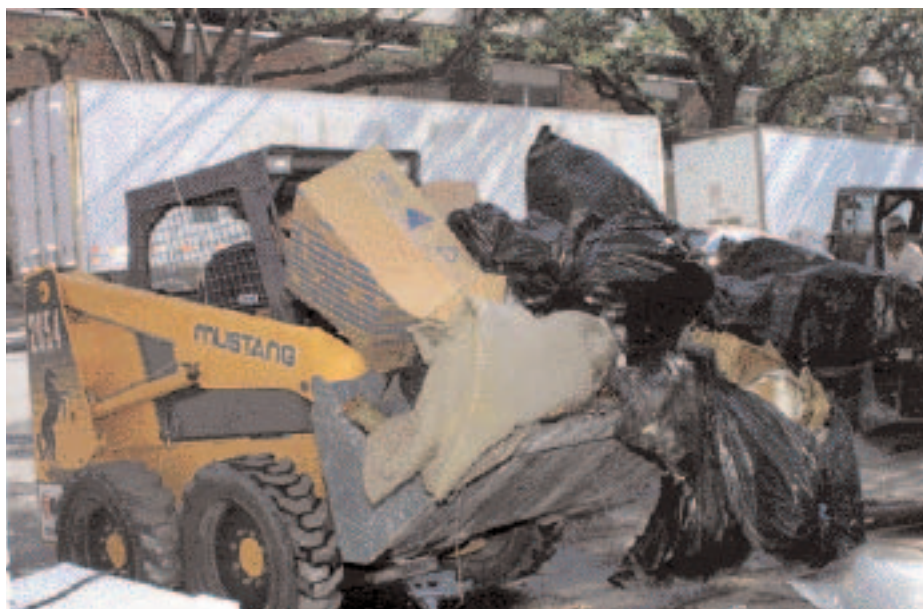
1. BELFOR removed over 95,000 cubic yards of damaged contents and debris from the Tulane Uptown Campus.
2. Pipes and mechanical equipment in low-lying areas across the campus, like these at the Physical Plant Logistics Building, were partially submerged and had to be cleaned and repaired.
3. BELFOR management and project leaders assembled each day to determine key paths of action and evaluate progress.

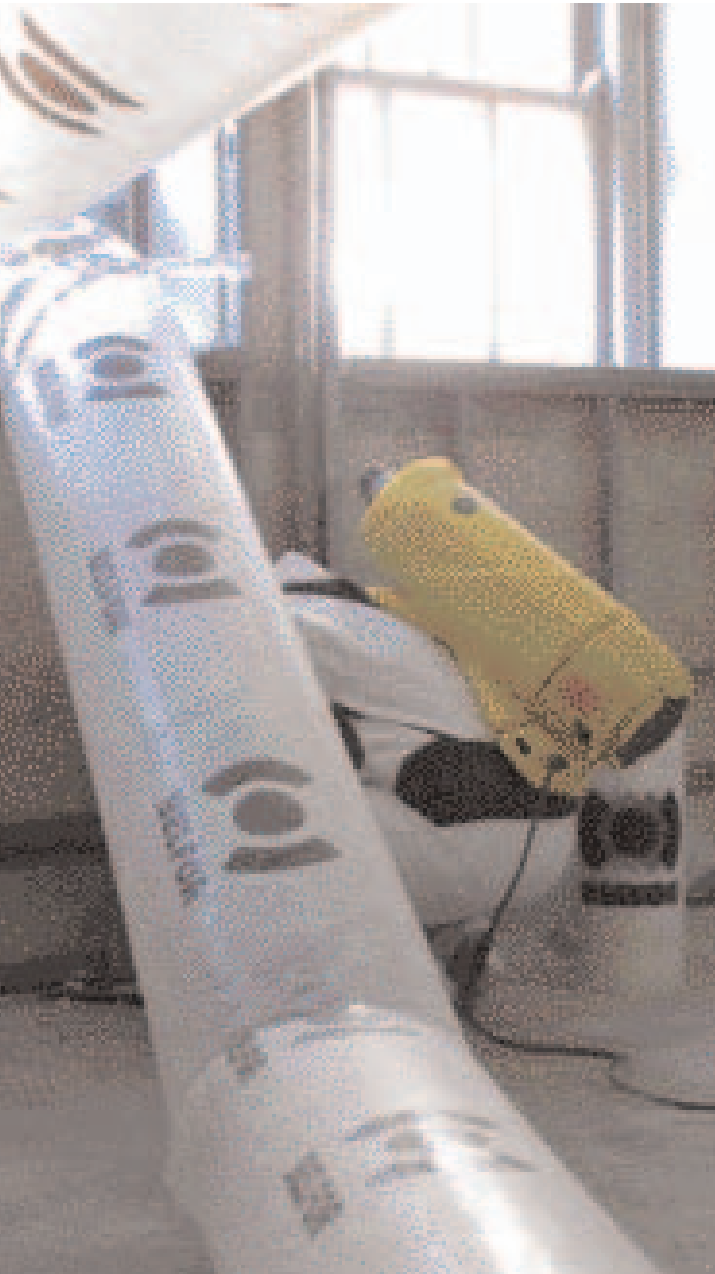
1. The upper floors of buildings received immediate attention with dry air in order to stabilize the interior environment and prevent further deterioration.
2. Workers cut out wet drywall from the structure to ensure any potential wet areas and mold growth were removed.
3. A desiccant dehumidifier was used to remove damp air and pump dry air into the building in order to stabilize the environment.
4. BELFOR is dedicated to safety and employees are always properly outfitted and taught the best ways to avoid potential risks.

Simultaneously, a mass of generators was brought in to power other buildings and deliver temporary ambient control to the upper floors, which prevents high heat conditions and the onset of mold and additional deterioration. One of the most problematic areas was the basement of the Howard-Tilton Memorial Library, which had flooded with eight feet of water. This area housed the University's music library, microfilm collection, Government documents, and protected storage collection, and Tulane administrators feared they would be completely destroyed. However, BELFOR moved quickly and was able to drain the water and retrieve 12,000 boxes of valuable books, film and documents. The items were stored in freezer trucks and moved to a large storage freezer at BELFOR's base operation. From there, these precious items were shipped to one of three document centers where they underwent processing, which also involved gamma radiation treatment to kill all contaminants. In addition, because of BELFOR's quick action in providing refrigerated, dry air to the top portion of the building, the first floor and all upper floors of the library escaped damage, were tested and passed all air quality clearance tests.
