PROPERTY RESTORATION

**Case Study: MINERAL COUNTY HIGH SCHOOL
Hawthorne, Nevada**

Loss Event: Faulty Roof Drain

Damage: Water Damage

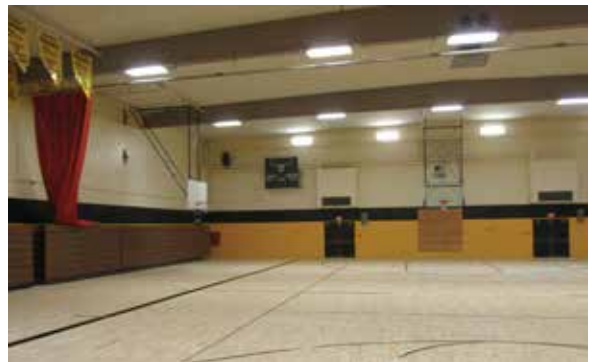
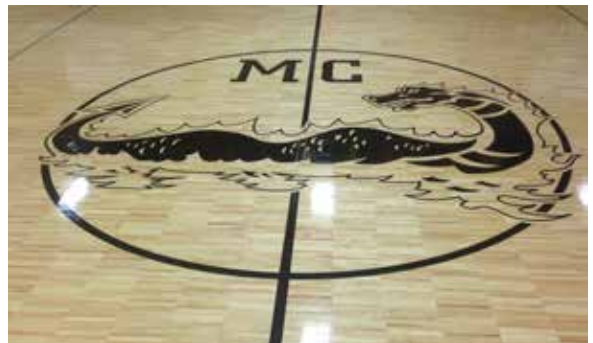
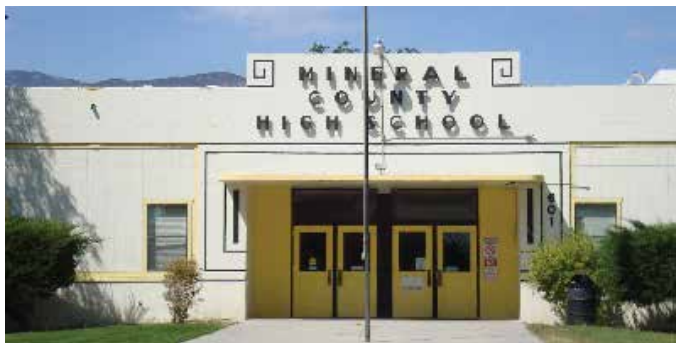
A faulty roof drain caused water to intrude on the Mineral County High School gymnasium floor in Hawthorne, Nevada. The original floor built in 1960 - herring bone wood flooring - began to buckle and an experienced restoration contractor was needed.

After a damage assessment, BELFOR Property Restoration discovered that the hardwood flooring was laid over a polyurethane athletic surface, over slab. In the 1960's, mercury was a common element in the manufacture of polyurethane athletic surfaces, much like lead in paint.

To avoid compromising the substrate containing mercury, only new flooring could be installed over the old flooring. Even if the old flooring could be removed safely, the herring bone wood flooring was no longer in production. BELFOR decided to dry the floor in place using dehumidifiers, standard air movers, and tenting on the impacted flooring.

After the floor was dried, BELFOR installed a new tongue and groove OSB (oriented strand board) overlay with a new hardwood floor over the existing floor. This action saved significant money without sacrificing safety for the school district and insurance PACT/pool.
