June 2012 • Vol. 49 No. 5

# Phoenix Award for Innovation in Reconstruction: Silver Lining

**BELFOR USA** Transforms a Dated Corporate Headquarters Following Fire

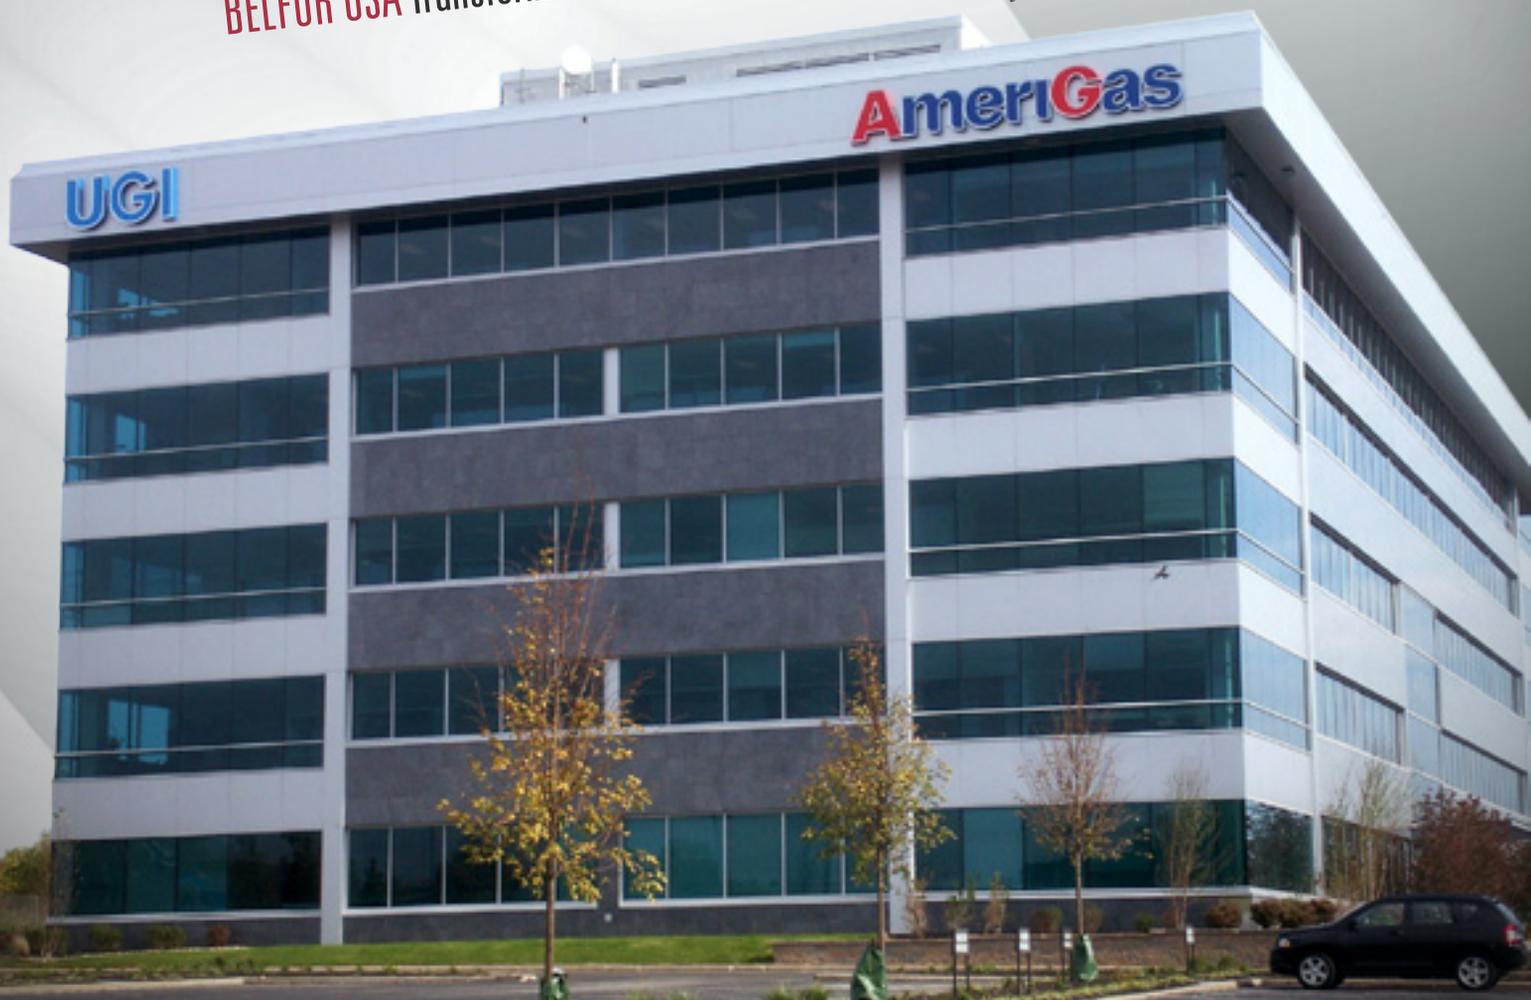
(Top) The entire façade was damaged by the fire and needed to be replaced. This led to the decision to update the look of the building.

Since the entire façade required replacement, UGI chose to update the exterior with granite panels and aluminum cladding. The existing window systems and overhangs were replaced, and 2,400 lineal feet of 8"x8" steel tubing was attached to the

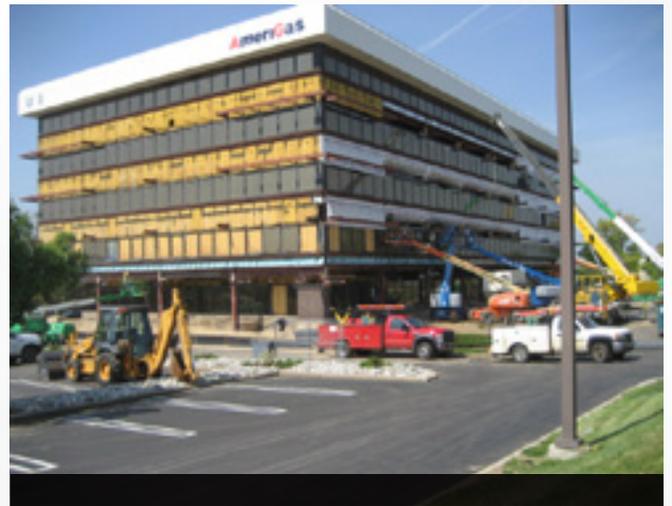
(Center) Placing and replacing scrim was a regular activity throughout the project. Maintaining this critical water barrier was essential to preserving the interior surfaces.

Buttaro says the most challenging part of the project was protecting the remaining interior finishes from the weather while sequencing and replacing the exterior façade of the building. He also says that the various aspects of the building turned out as anticipated, particularly the new façade. "This project confirmed that anything is possible when everyone works together and keeps their commitments," he adds.

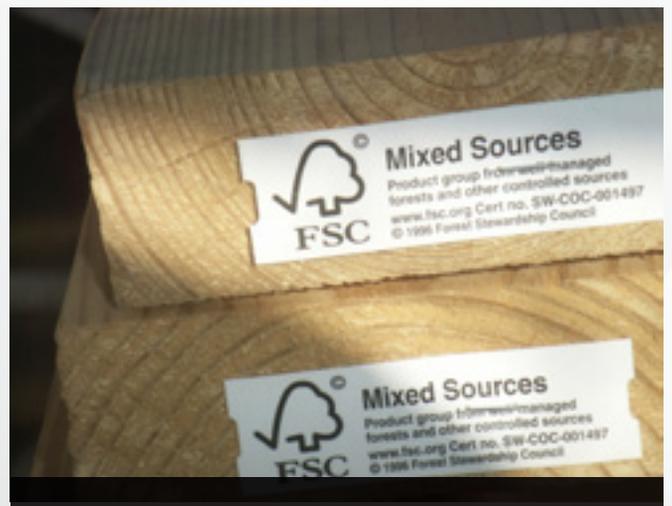
(Bottom) Forest Stewardship Council certification ensured that the lumber used in the job came from sustainable sources.

Working with BELFOR LEED-certified professionals and a UGI LEED architect, they were able to certify that the building was green-compliant. Careful records were kept throughout the reconstruction for the LEED process. Over 50 percent of the wood used in the project was certified by the Forest Stewardship Council (FSC), meaning that the wood came from forests specifically grown and maintained for harvest. Each piece of wood is stamped and requires a chain of custody. Wood that is not FSC-certified also had to be noted and logged. In addition, BELFOR used recycled steel, concrete and aluminum as part of the project.
